**DEPARTMENT OF TRANSPORTATION****DIVISION OF ENGINEERING SERVICES**

Quality Assurance and Source Inspection

Contract #: 04-0120F4Cty: SF/ALA Rte: 80 PM: 13.2/13.9File #: 13.28**WELDING INSPECTION REPORT****Resident Engineer:**Pursell, Gary**Address:** 333 Burma Road**City:** Oakland, CA 94607**Report No:** WIR-006228**Date Inspected:** 14-Apr-2009**Project Name:** SAS Superstructure**OSM Arrival Time:** 700**Prime Contractor:** American Bridge/Fluor Enterprises, a JV**OSM Departure Time:** 1530**Contractor:** Oregon Iron Works Clackamas, Or.**Location:** Clackamas, OR**CWI Name:** Mike Gregson, Rob Walters**CWI Present:** Yes No**Inspected CWI report:** Yes No N/A**Rod Oven in Use:** Yes No N/A**Electrode to specification:** Yes No N/A**Weld Procedures Followed:** Yes No N/A**Qualified Welders:** Yes No N/A**Verified Joint Fit-up:** Yes No N/A**Approved Drawings:** Yes No N/A**Approved WPS:** Yes No N/A**Delayed / Cancelled:** Yes No N/A**Bridge No:** 34-0006**Component:** Hinge K Pipe Beams**Summary of Items Observed:**

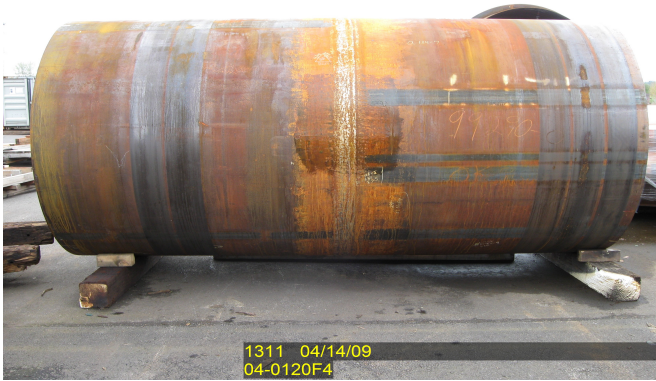
Hinge-K Pipe Beam Fuse Assembly 120A-1:

QA Inspector reviewed the applicable OIW non-destructive testing reports, including Visual, Magnetic Particle (MT-2244-125), Ultrasonic (UT-2244-24) and noticed that no rejectable indications were found by OIW QC Inspectors.

QA Inspector performed approximately 10% ultrasonic weld inspection on the CJP (AWS D1.5 B-U3c-S) fuse splice (a124-7/a124-6), designated as weld joint #WM3-18 and found no rejectable indications. QA Inspector notified QC Inspector Mike Gregson of these results and completed the applicable ultrasonic testing report (TL6027). See completed fuse splice in attached picture below.....
